On-line Diagnosing on Trayed Column of Etylene Plant Using Gamma Ray Scanning

S. Sugiharto*

Center for Application of Isotopes and Radiation Technology, National Nuclear Energy Agency
Jl. Lebak Bulus Raya No 49, Jakarta 12440, Indonesia

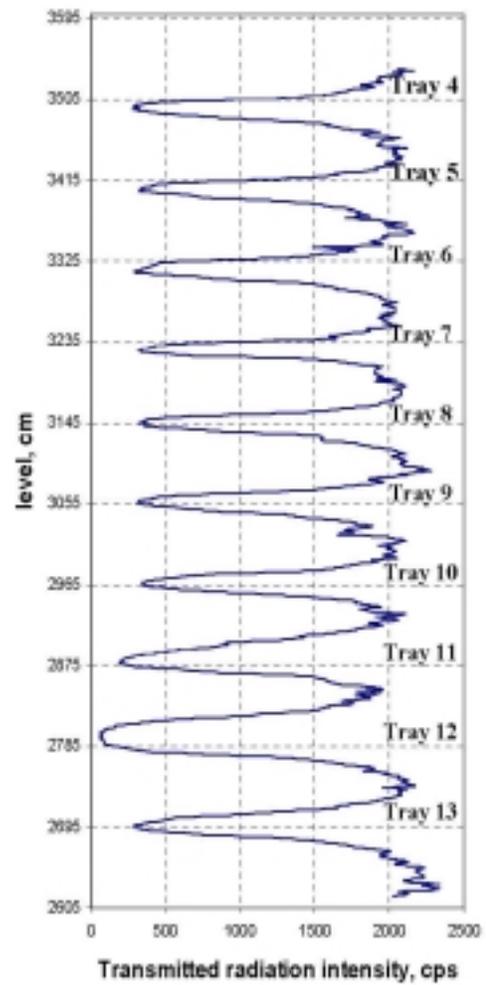
Fig. 4. Profile of Tower DA-202 obtained from scan orientation 2. The source and the detector were positioned 575 mm (1.5°) and 575 mm (178.5°) respectively. Trays # 4 to # 10 and tray # 13 were in position and carried approximately the same amount of liquid. Flooding on tray # 11 and tray # 12 were observed as indicated by their lower and wider scan curve.

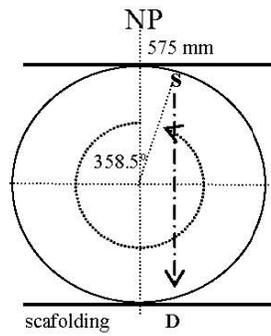
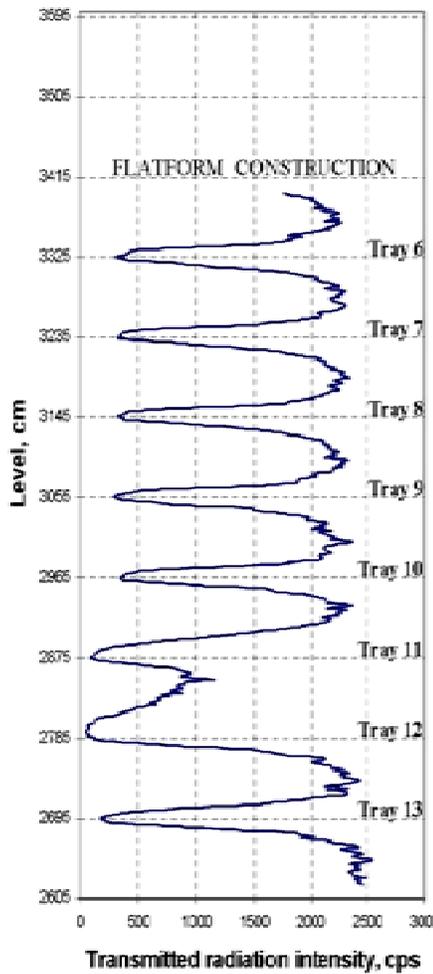
Fig. 5. Profile of Tower DA-202 obtained from scan orientation 3. The source and the detector were positioned 575 mm (358.5°) and 575 mm (181.5°) respectively. Trays # 6 to # 10 was carried approximately the same amount of liquid. Light flooding on trays # 11 and # 13 were observed. Flooding and solidified materials on tray # 12 was observed.

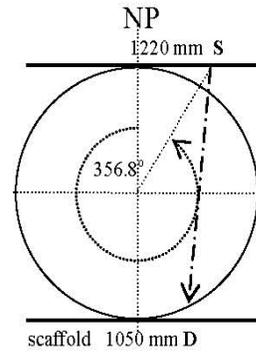
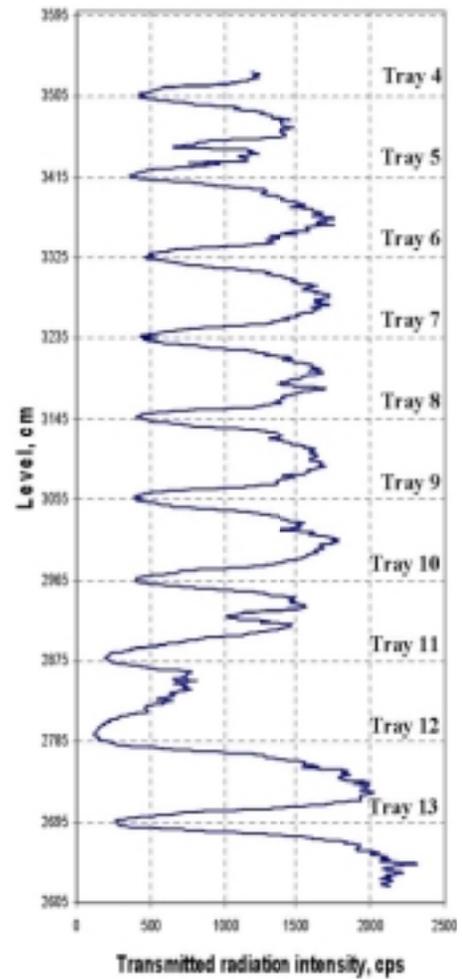
Fig. 6. Profile of Tower DA-202 obtained from scan orientation 4. The source and the detector were positioned 1220 mm (356.8°) and 1050 mm (182.7°) respectively. Trays # 4 to # 10 was carried approximately the same amount of liquid. Light flooding on trays # 11 and # 13 were observed. Flooding and solidified materials on tray # 12 were observed.

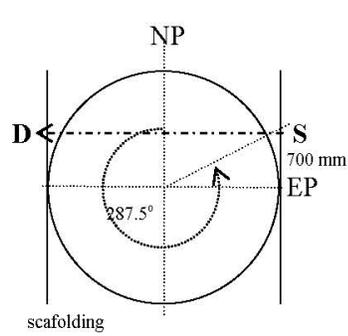
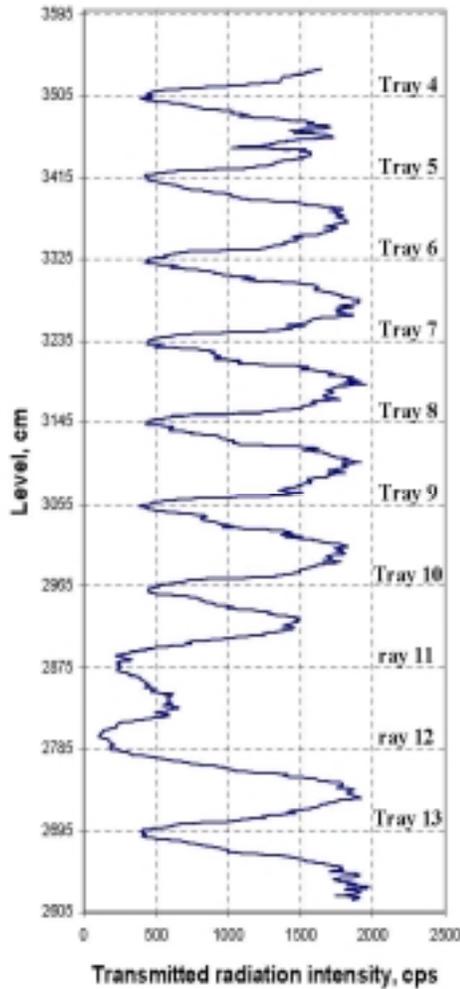
Fig.7. Profile of DA-202 tower obtained from scan orientation 5. The source and the detector were positioned at 700 mm (287.5°) and 700 mm (72.5°) respectively. Trays # 4 to # 10 was carried approximately the same amount of liquid. Light flooding on trays # 11 and # 13 were observed. Heavy flooding and solid material on tray # 12 was observed.

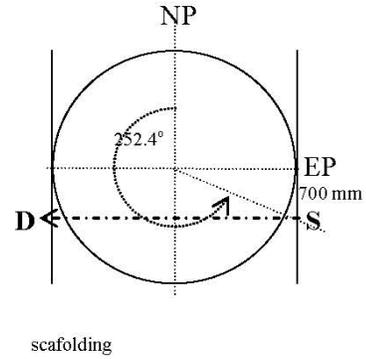
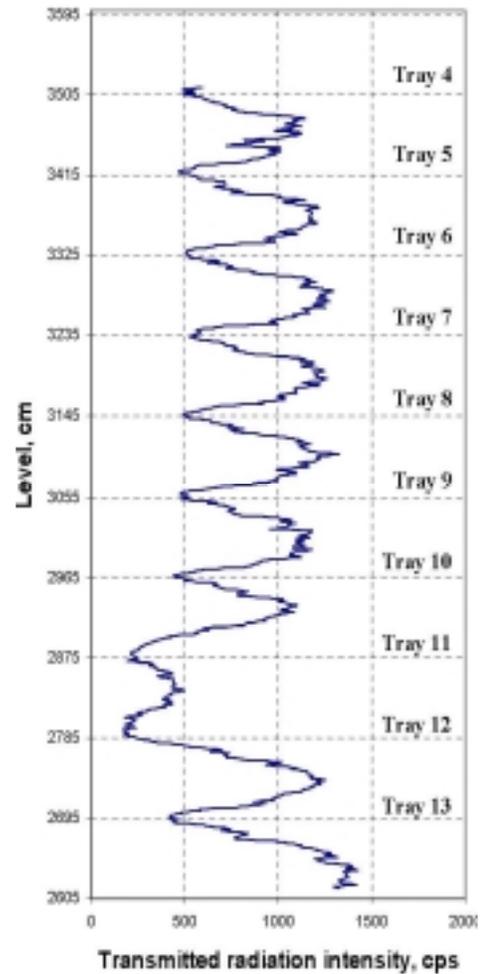
Fig. 8. Profile of DA-202 tower obtained from scan orientation 6. The source and the detector were positioned 700 mm (252.4°) and 700 mm (107.6°) respectively. Trays # 4 to # 10 was carried approximately the same amount of liquid. Light flooding on trays # 11 and # 13 were observed. Heavy flooding and solid material on tray # 12 was observed

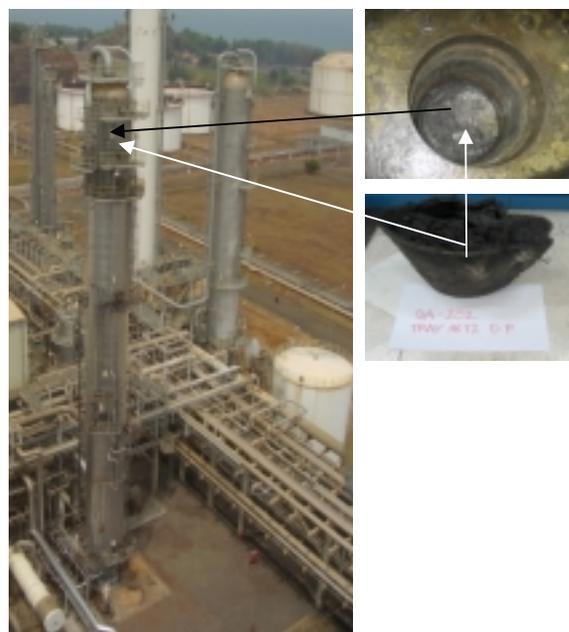
Presence of solid material on tray # 12 may disturb liquid flow either through downcomer or down pipe. The location of the solid material on tray # 12 can be predicted by analyzing the density change of the scan data. Suppose that the cross-section of the column is divided into four quadrants as shown in Fig. 2. Scan on quadrants II and III did not shows any significant anomalies except for flooding on trays # 11 and # 12 only. Scan through quadrants I and IV, however, indicates very different features on which low and wide radiation intensity on tray # 12 was observed. This indicates that the solid material has grown on quadrant I and IV of the tray # 12. At the time of shutdown, two years after completion scanning work, it was found that the solid material on the tray #12 was a bucket buried in solidified mud, as shown in Fig. 9.

Presence of metallic bucket in down pipe of the tray # 12 is not expected to exist and it origin can be traced back to the time of last shutdown period when plant maintenance was carried out. Somebody put the bucket in the down pipe beyond the surveillance of project supervisor or plant engineers. This fact shows a carelessness of

Fig. 9. Suspicious solidified material observed by gamma scanning was verified at the time of shutdown. A bucket buried in solidified mud was found on tray # 12 of DA-202 tower.

As can be seen from Fig. 9 (top-right), the deposit was dominated by particulate matter. Deposit material due to chemical reaction including corrosion is also observed as indicated by visibly metallic freck on top surface of the tray. Particulate deposit as mud may originate from feedwater containing mud particles. Metallic deposit on the other hand surely caused by plant operating conditions which including high pressure, high temperature and processing materials. Presence of such deposit including bucket on tray # 12 leading to reduce its efficiency.
